**TEST REPORT**

**Report No.:** E6827.01-602-47

AD SKYLIGHTS, INC.  
Algonquin, Illinois

**PRODUCT TYPE:** Fixed Curb Mount Skylight  
**SERIES/MODEL:** AD Skylight with guard  
AD Skylight without Guard

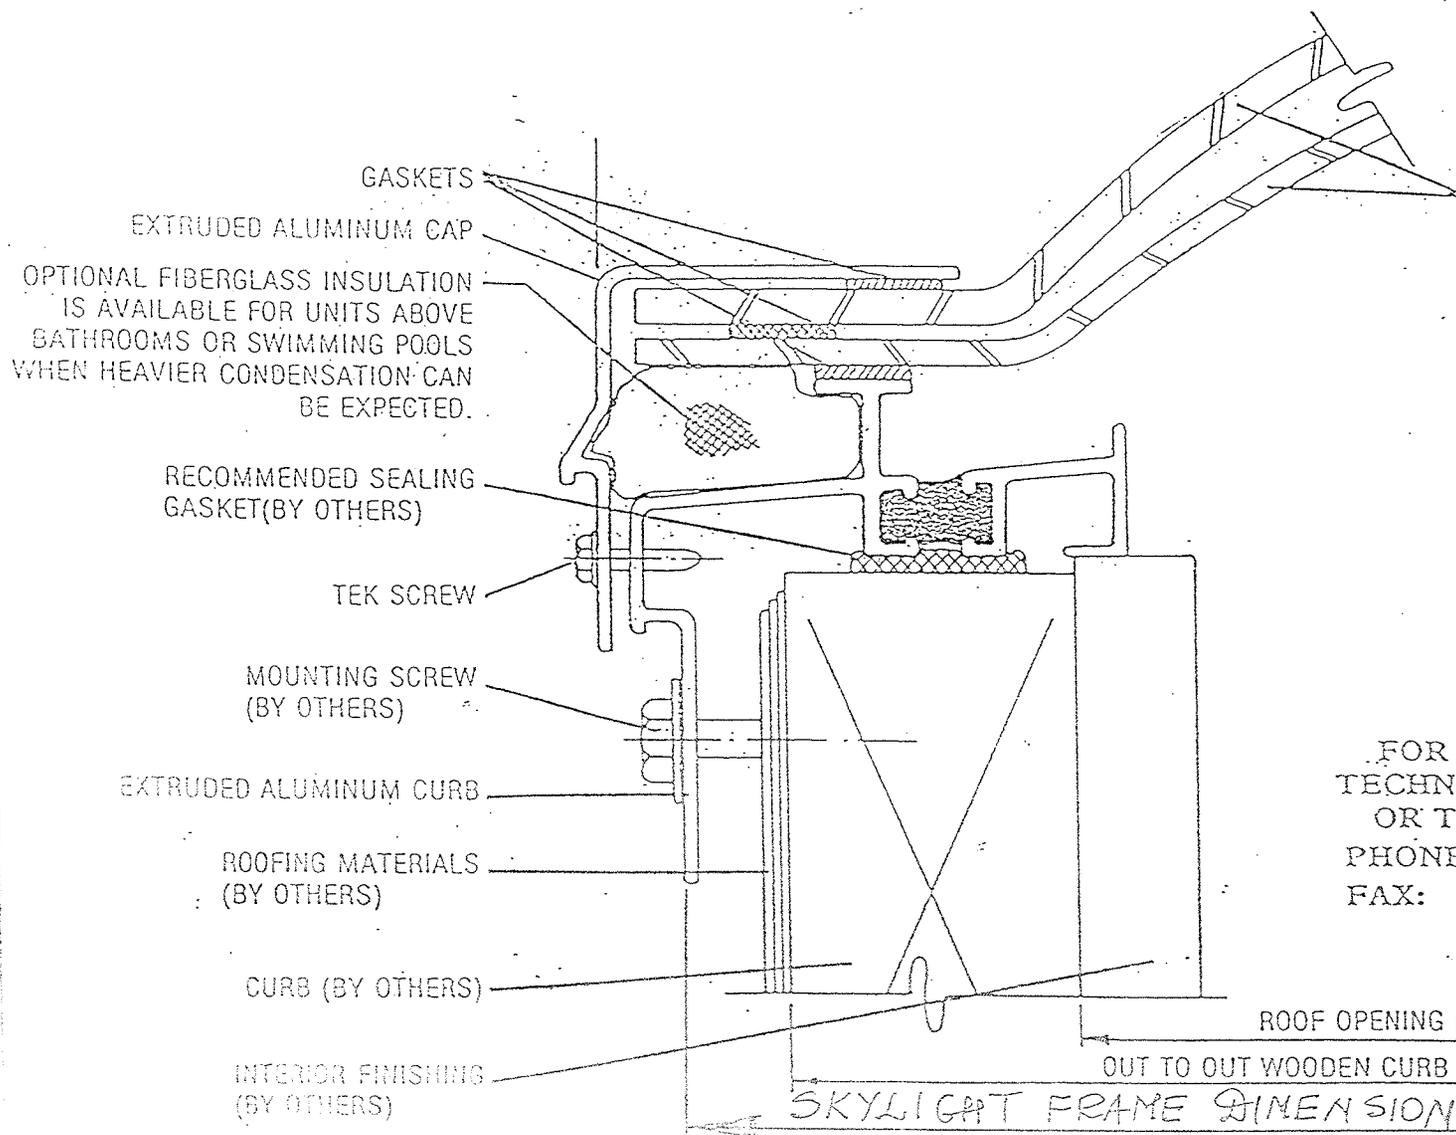
## CURB SECTION OF STANDARD TR THERMALY BROKEN CURB MOUNTED UNIT

ACRYLIC GLAZING:  
 IN PLASTIC SINGLE, DOUBLE OR  
 EVEN TRIPLE DOMES OR  
 PYRAMIDS, OR COMBINATION  
 OF THEM ARE AVAILABLE.  
 GLASS UNITS ARE ALSO AVAILABLE.

FRAMING-THERMALY BROKEN  
 EXTRUDED ALUMINUM FRAME  
 AVAILABLE IN MILL, ANODIZED OR  
 PAINTED FINISH.
